Manhole Inspection Summary

Manhole # S31M__001MH

Insp Date: **12/26/08 8:55 AM**

Location Address: **Warner St**

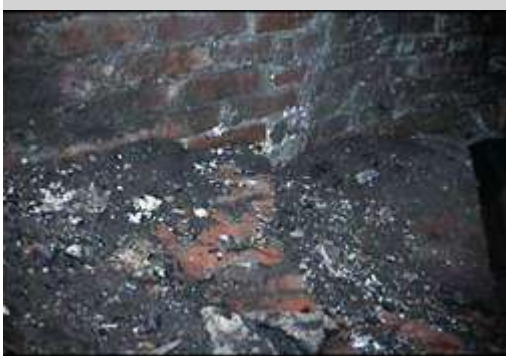
Miscellaneous

debris on bench and two tier level bench

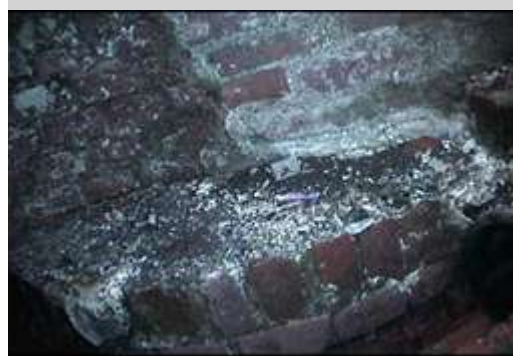
Miscellaneous

debris on bench

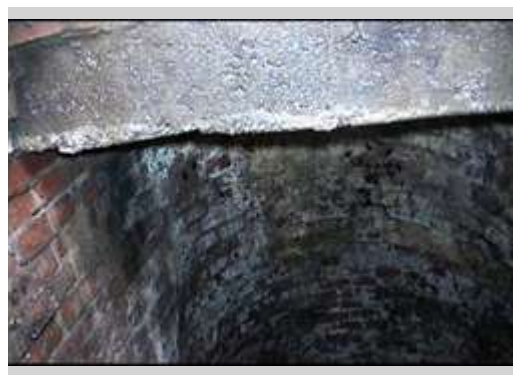
Miscellaneous

flat top half of mh

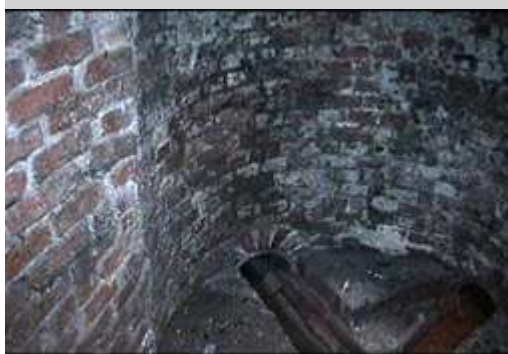
Miscellaneous

Pipes under shelf

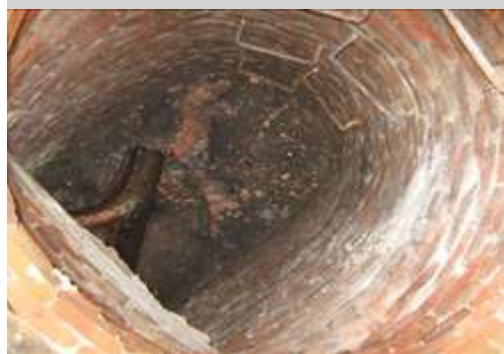
Defect 1

Count: **6** Missing: **0** ☒ **Corroded**

corroded steps

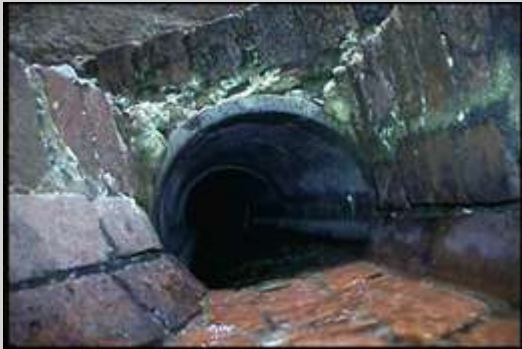
12 O'Clock Outflow

10 in. Circular Gravity Sewer
Pipe Out @ 12 O'Clock

Invert Depth: **12.30** (ft.) Flow Characteristics: **Fast**

Infiltration: **None** Pipe Seal Cond: **Sound**

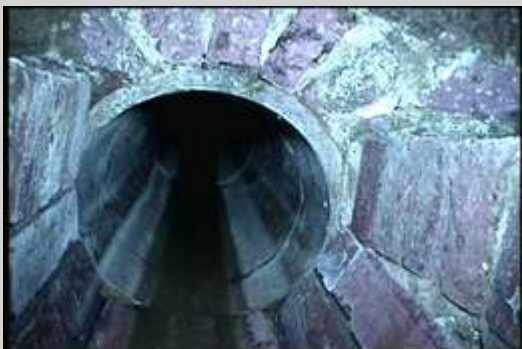
6 O'Clock Inflow

10 in. Circular Gravity Sewer
Pipe In @ 6 O'Clock

Invert Depth: **12.00** (ft.) Flow Characteristics: **None**

Infiltration: **None** Pipe Seal Cond: **Sound**

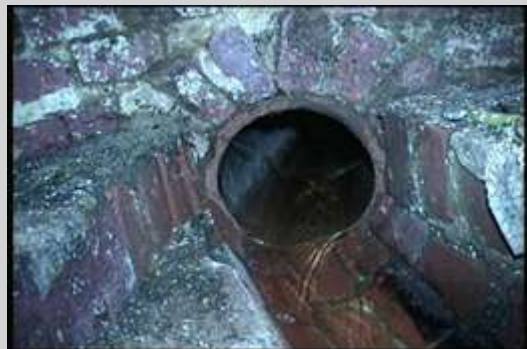
9 O'Clock Inflow

8 in. Circular Gravity Sewer

Pipe In @ 9 O'Clock

Infiltration: **None** Pipe Seal Cond: **Sound**
